Manhole Inspection Summary

Manhole # **S15G1_008MH**

Insp Date: **4/17/08 11:23 AM**

Location Address: **3101 patapsco-gable industrial complex**

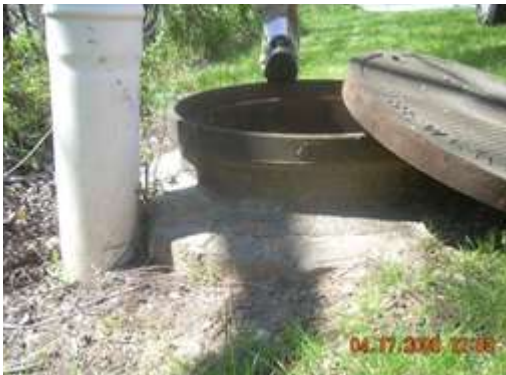
Miscellaneous

above grade

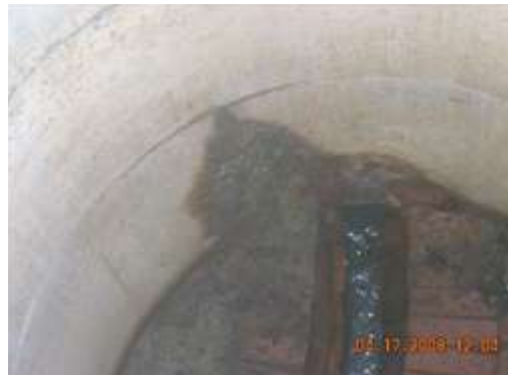
Defect 2

Barrel Material: **Precast Concrete** ☐ Parged
Shape: **Circular** Diameter: **48** (in.) Length: **0** (in.)
Condition: ☒ Sound ☐ Cracked ☐ Root Intrusion ☐ Loose Brick ☐ Deteriorated
Infiltration: ☐ None ☒ **Joint** ☐ Cracks ☐ Mortar ☐ Roots ☐ Wall

infiltration @ barrel/corbel joint

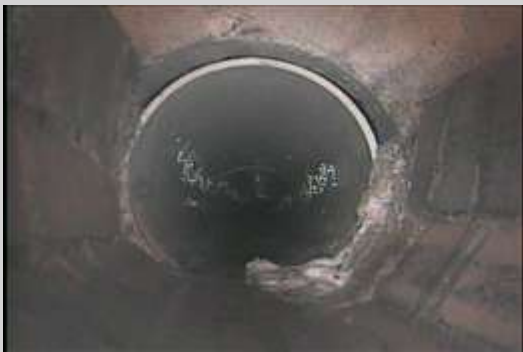
12 O'Clock Outflow

8 in. Circular Gravity Sewer
Pipe Out @ 12 O'Clock

Pipe Height: **8.4** (in.) Rod and Bar (Angled)
Pipe Material: **PVC** ☐ Pipe Lined
Invert Depth: **11.03** (ft.) Flow Characteristics: **Slow**
Deposits: ☐ None ☐ Mud ☒ **Sludge** ☐ Debris ☐ Grease
Silt Depth: **1** (in.) Deposits Extent: **Light**
Infiltration: **None** Pipe Seal Cond: **Sound**

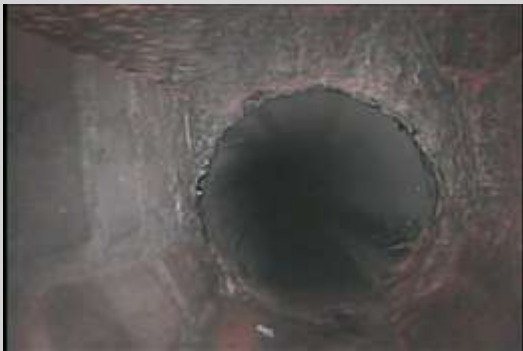
5 O'Clock Inflow

8 in. Circular Gravity Sewer
Pipe In @ 5 O'Clock

Pipe Height: **8.4** (in.) Rod and Bar (Angled)
Pipe Material: **PVC** ☐ Pipe Lined
Invert Depth: **11.01** (ft.) Flow Characteristics: **Slow**
Deposits: ☒ None ☐ Mud ☐ Sludge ☐ Debris ☐ Grease
Silt Depth: **0** (in.) Deposits Extent:
Infiltration: **None** Pipe Seal Cond: **Unknown**
